Rock Art Management and Landscape Change: Mixed Field Assessment Techniques for Cultural Stone Decay

Rock Art Management and Landscape Change:
Mixed Field Assessment Techniques for Cultural Stone Decay

A dissertation submitted in partial fulfillment
of the requirements for the degree of
Doctorate of Philosophy in Environmental Dynamics

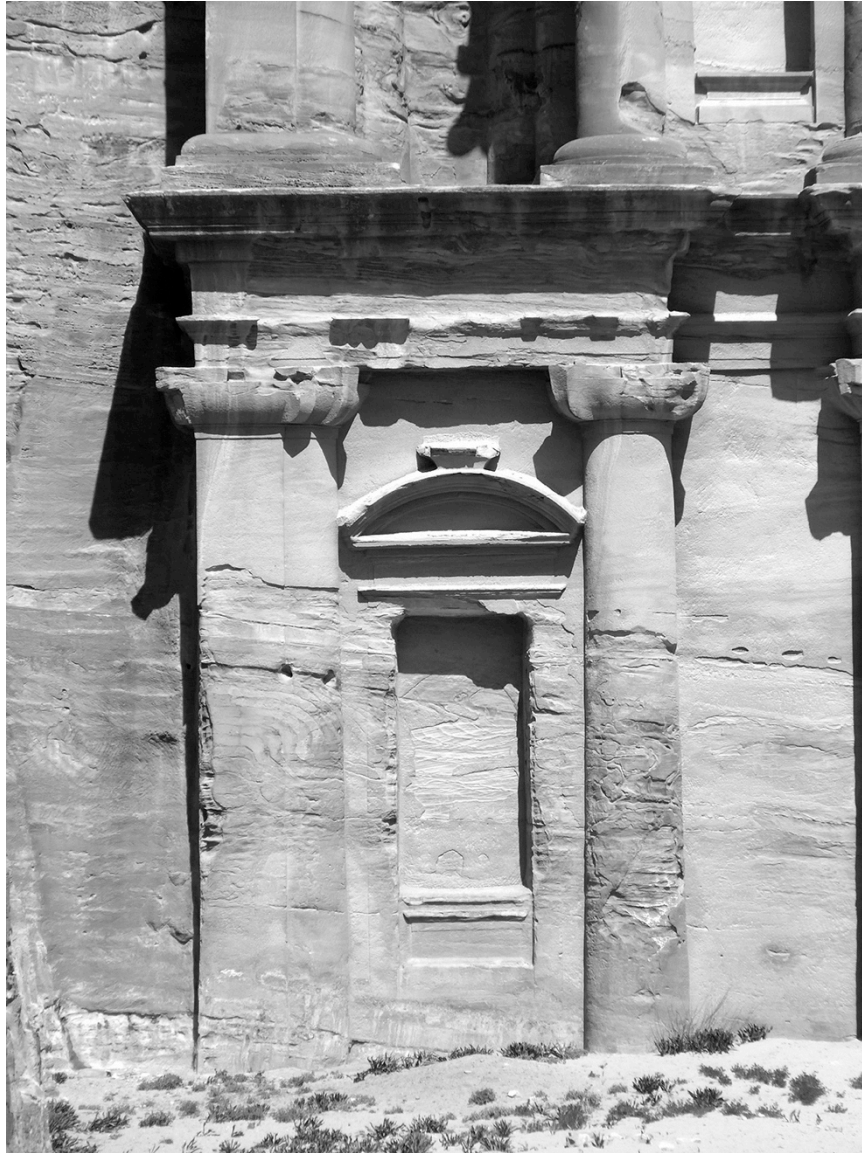
Figure 6.6: Closer photograph of the textural anomalies on the Deir Panel 12. Much of the horizontal striations and red coloration are exposed areas of the host sandstone where the stone dressing has deteriorated. The green patches are small bushes (roughly 0.5 meters diameter) for scale reference. Some graffiti and vandalism can be found on the lower sections of both columns. Photograph by author, 2016.

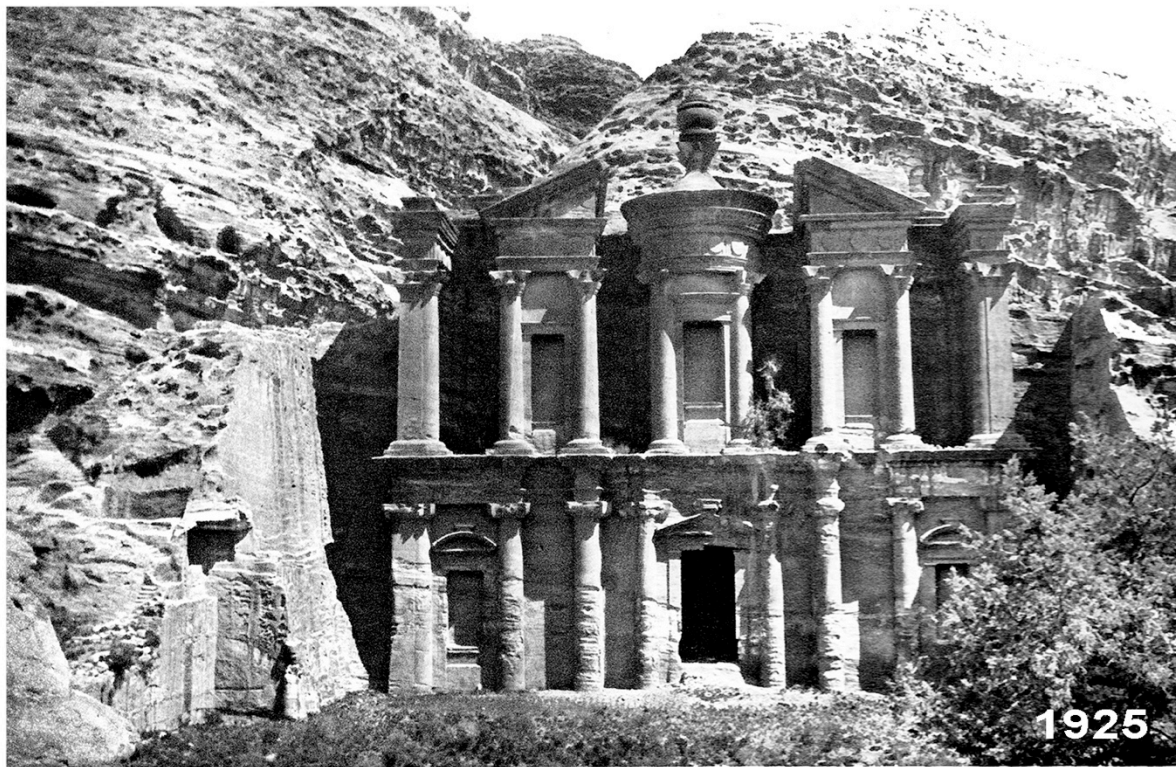
Figure 6.7: Repeat photographs of the Deir (The Monastery). 1925 photograph from A. B. W. Kennedy (1925). 2016 photograph by author.

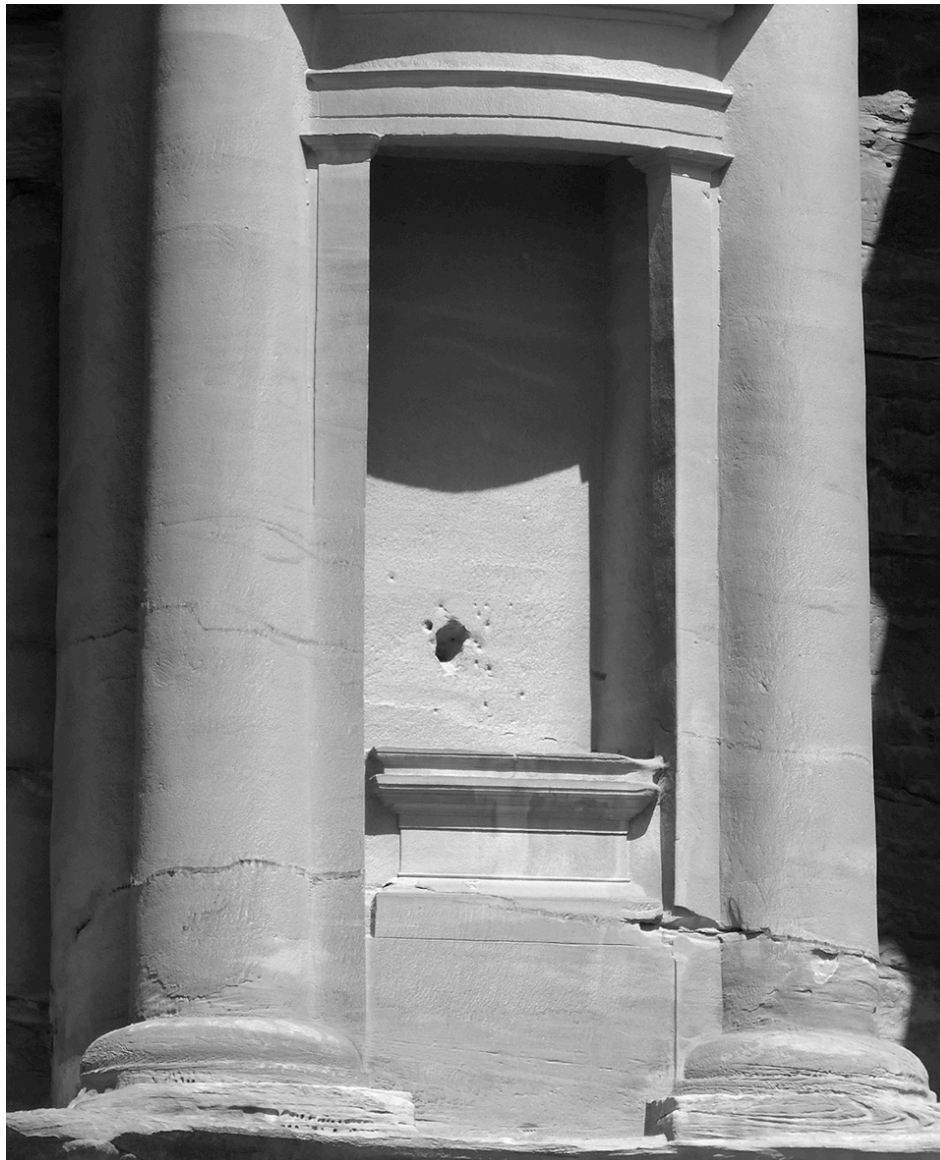
Figure 6.8: Closer view of the bullet holes and damage within the highest false window, or niche, of the Deir. This inset is in the center panel of the second floor, directly beneath the monument's iconic cone spire and urn decoration. Photograph by Casey Allen, 2016.

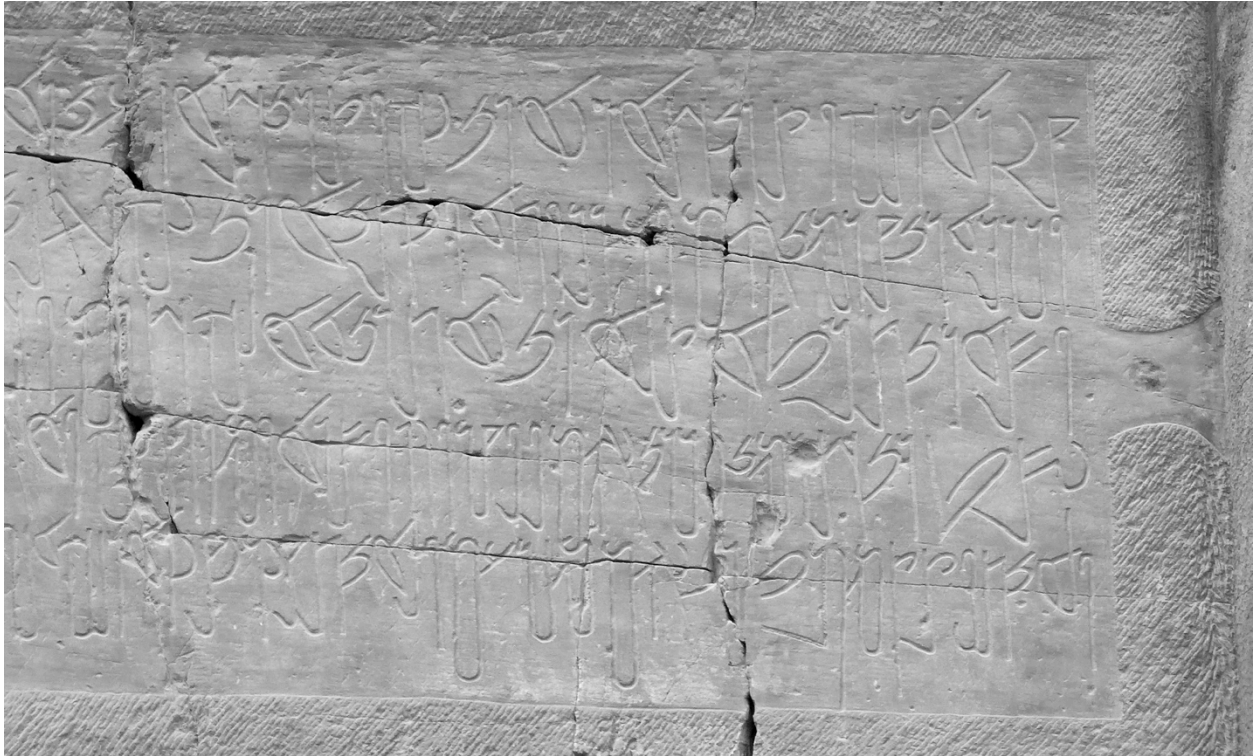
Figure 6.10: Section of the Nabataean inscription at the Turkmanyia Tomb. Translations of the inscription reveal a list of social and legal conditions for interment within the tomb. The engraving also represents one of the longest and most intact Nabataean writings in the region. Photograph by Casey Allen, 2016.

That said, the one element that makes the Turkmanyyia unique—the Nabataean inscription—is relatively stable (Figure 6.10). Illustrating the flexibility of CSSI panel designations, the Turkmanyyia assessment utilized three separate panels, at different scales, to analyze the stability of inscription. The

widest assessment, panel 5, encompassed the entire architectural feature on which the inscription is located, including adjacent pillars and design elements. With an average CSSI score of 64.0, this panel is within the *Severe Danger of Erosion* category and rated particularly high in independent fissures, undercutting (both impending and present), and invasive bird activity (e.g. nesting, bird droppings, etc). The next inscription assessment scale, panel 7, incorporated the dressed rectangle housing the inscription and its immediate surroundings—no other pillars or decorative elements beyond the inscription. Scoring lower (CSSI average of 55.3: *Great Danger of Erosion*), this panel excluded the severe decay occurring along the outer edges of the broader feature assessed as part of panel 5. Within this more focused area, CSSI identified the largest risks as independent fissures, inherent rock weakness, undercutting, and abrasion. The final inscription assessment, panel 8, concentrated solely on the small area actually containing writing. Working in a much smaller area than the other feature areas, this panel only scored 38.0 (*Problems that Could Cause Erosion*), with the biggest problems identified as

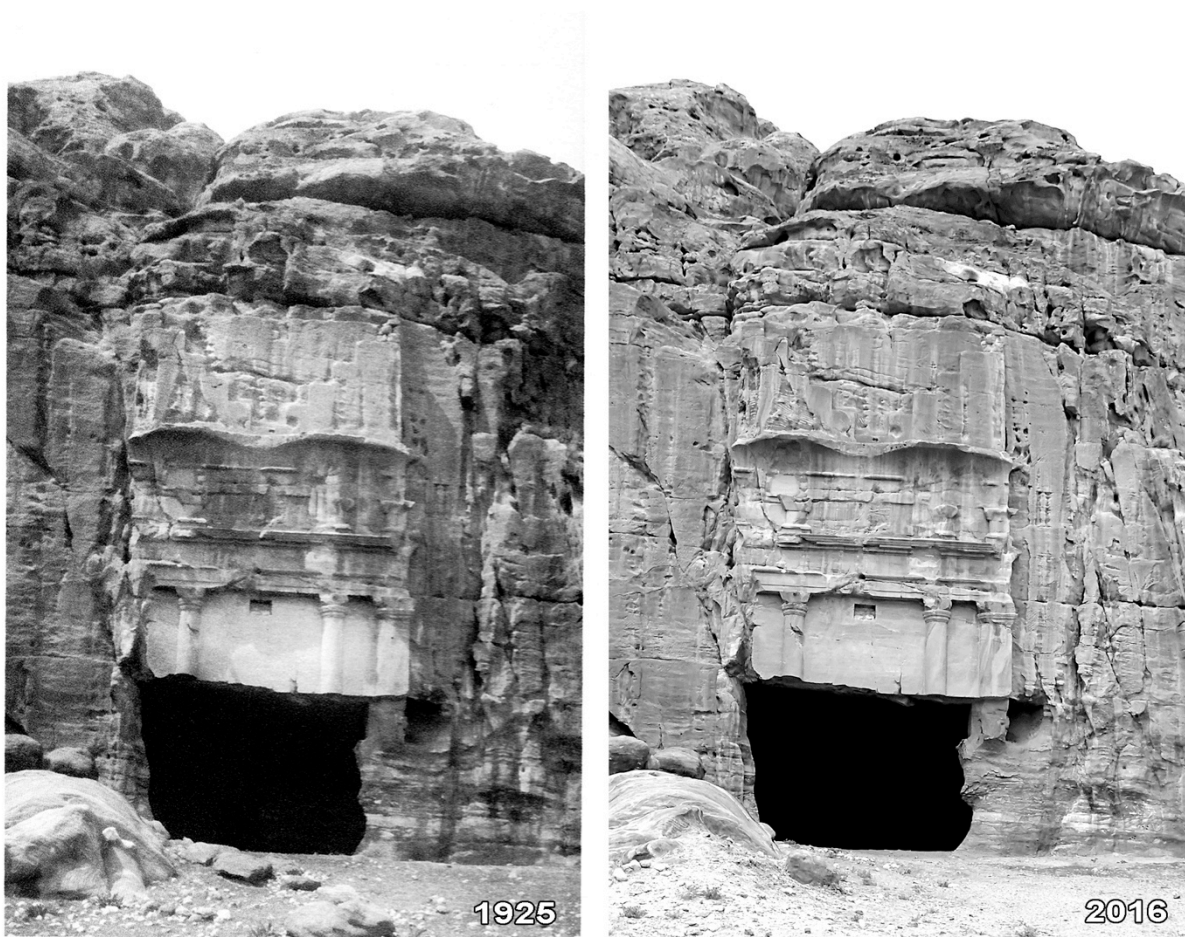
Figure 6.11: Repeat photographs of the Turkmanyia Tomb. 1925 photograph from A. B. W. Kennedy (1925). 2016 photograph by author.

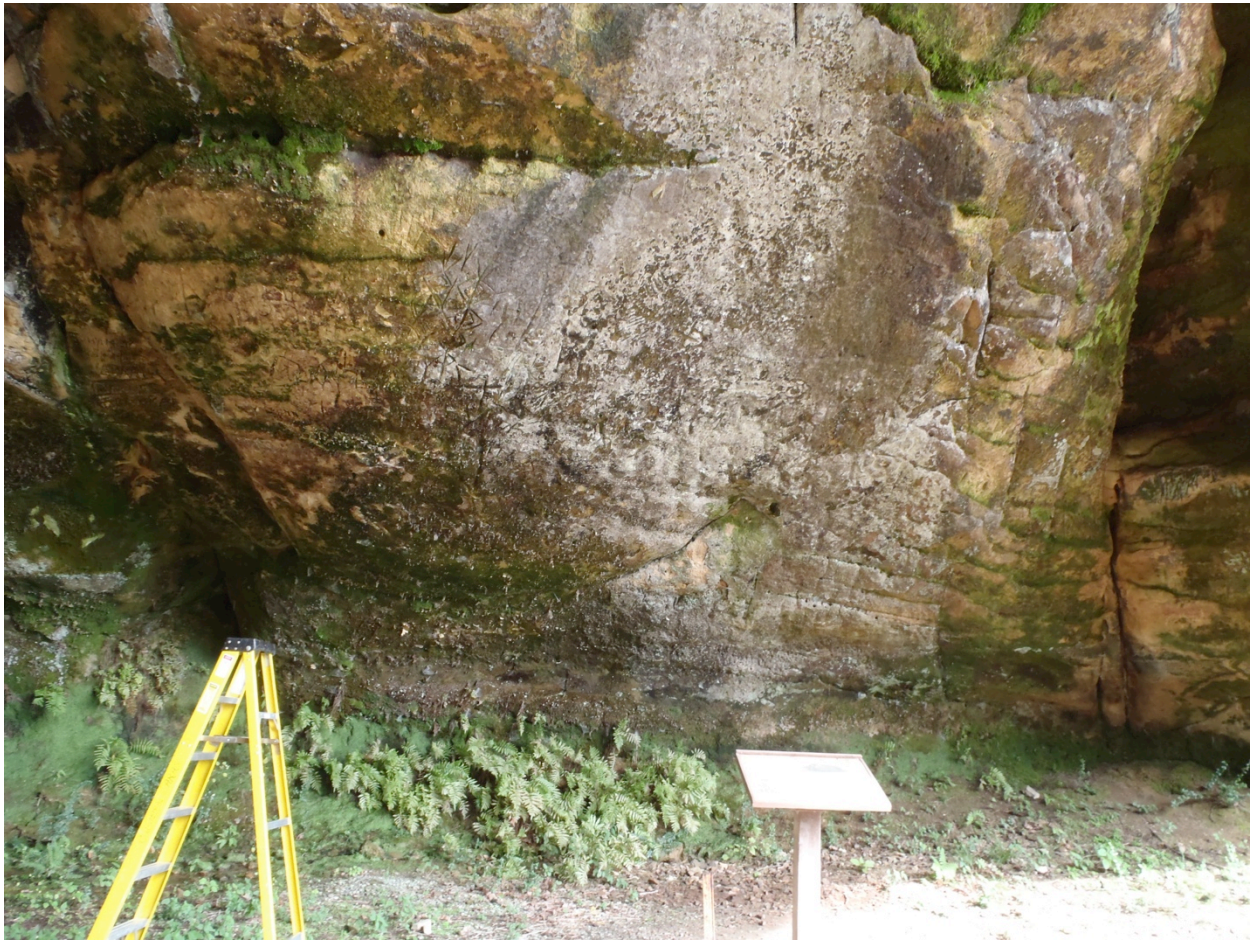
A.6 – Primary wall containing petroglyphs at Edgemont with ladder and sign for scale. From this distance the rock art is extremely difficult to see due to the rampant lichen and moss growth that covers most of the wall. Photograph by author, 2014.

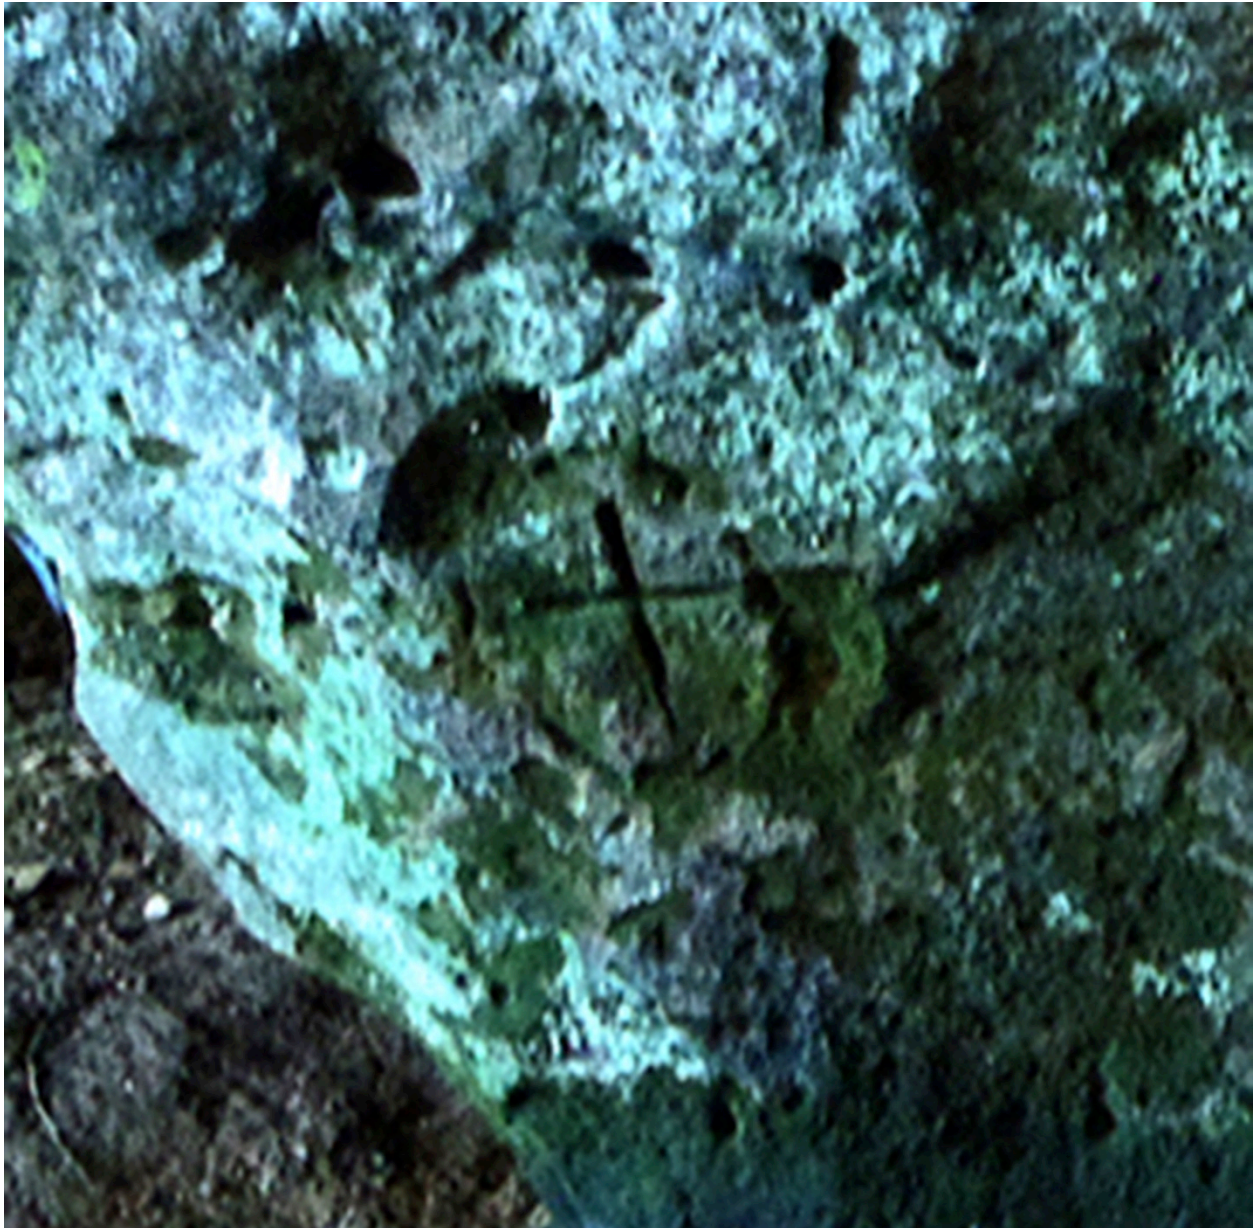
B.2 – Front and back of completed RASI score sheet for the Narrows Panel 4.

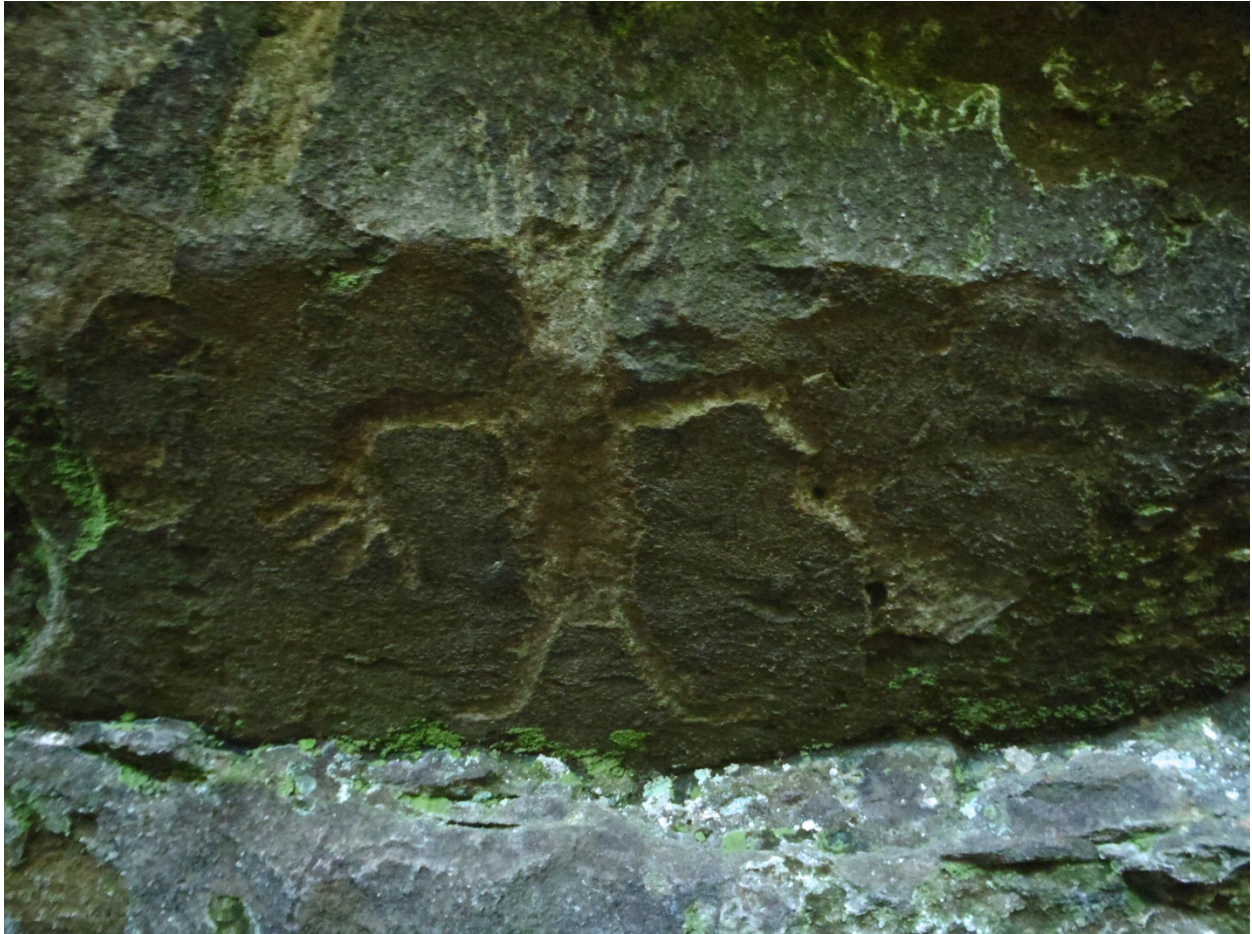
B.5 – Front and back of completed RASI score sheet for the Narrows Panel 7.

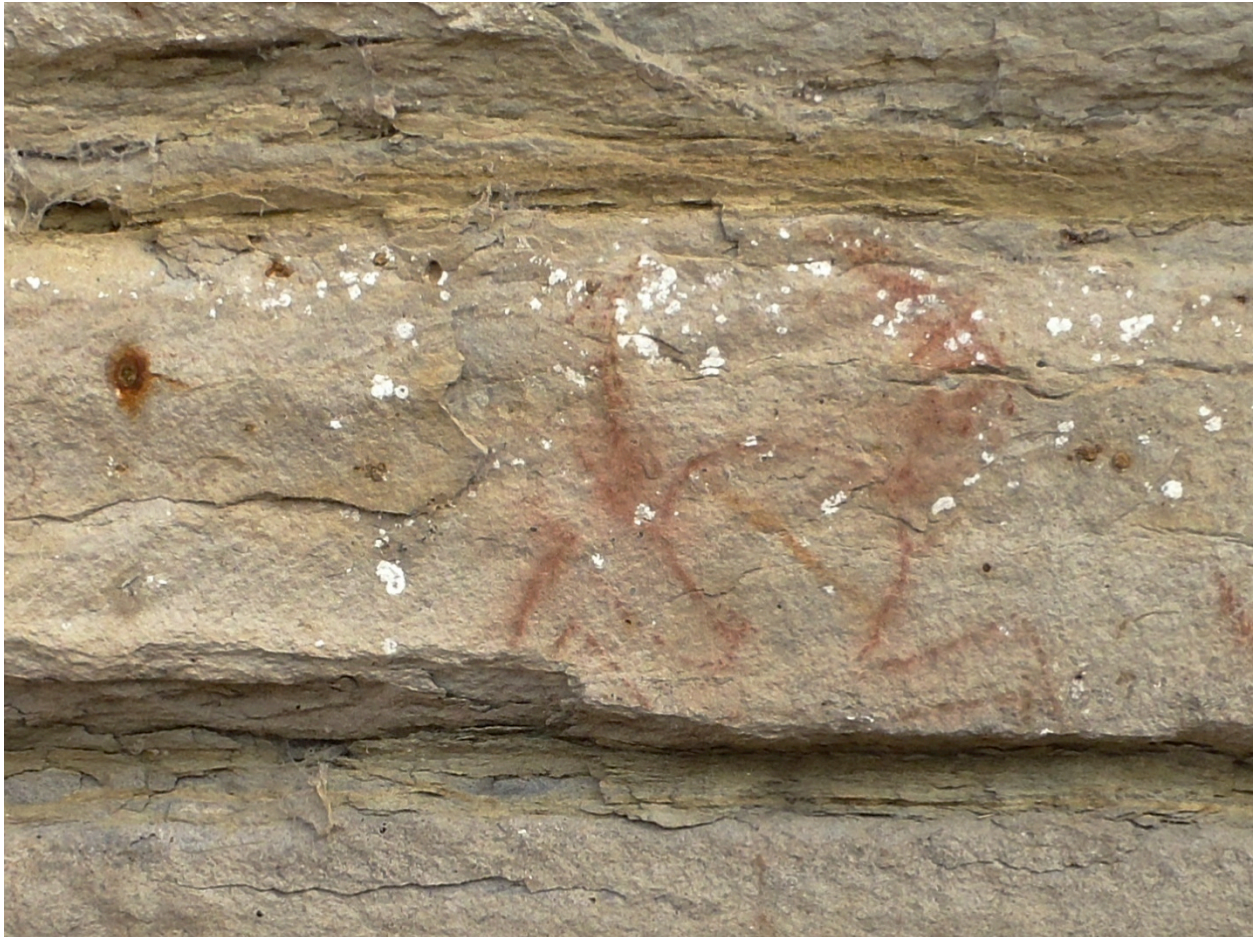
B.7 – Putnam Panel AS-1, commonly called “the Buffalo”. Although this panel was actually at an adjoining site, its uniqueness in motif, design, and quality earned its inclusion in this case study. The panel is also different from most of Putnam in that it is clearly visible from the water, although it is difficult to reach on land. Photograph by author, 2014.

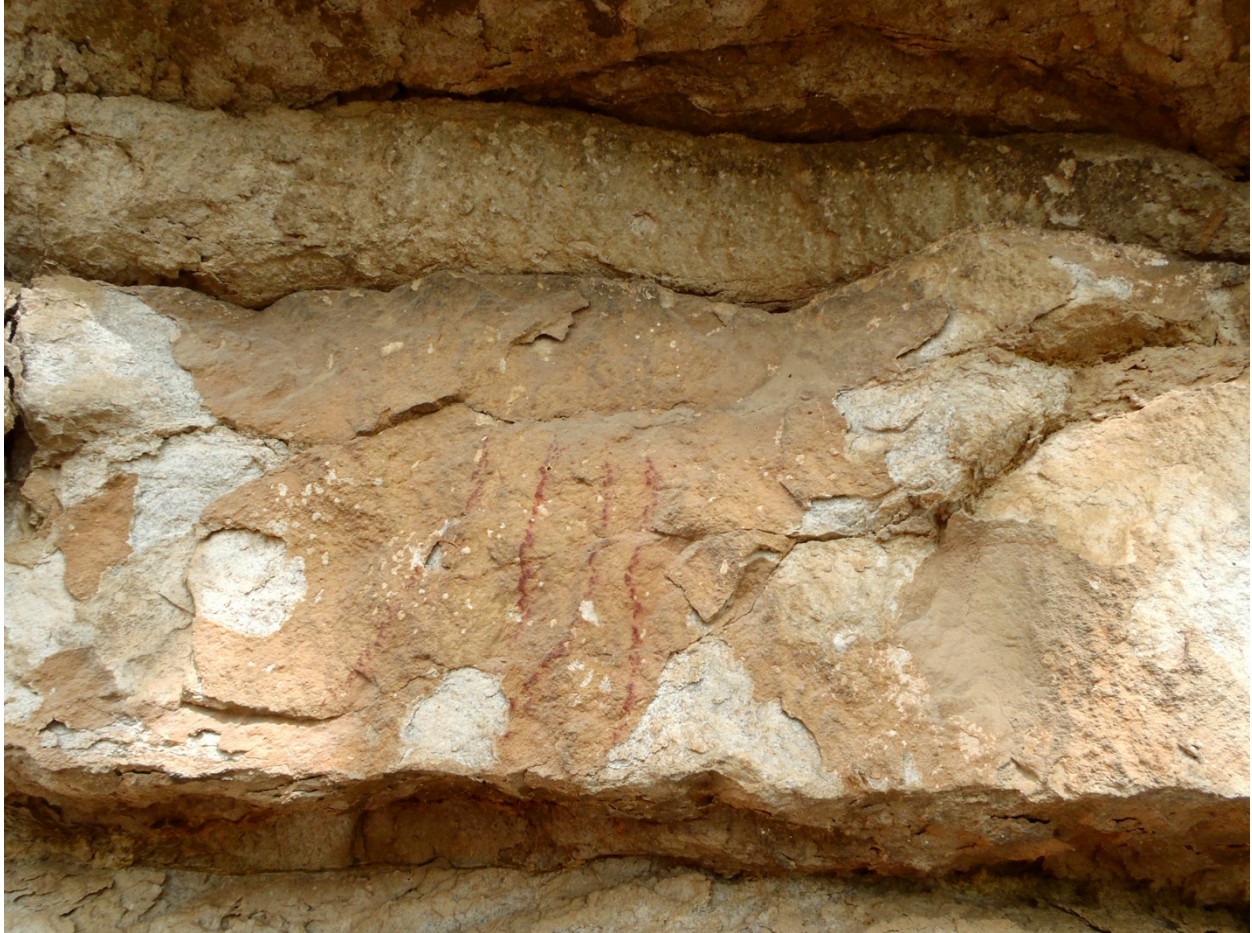
B.11 – Front and back of completed RASI score sheet for Putnam Panel UR-E 33.

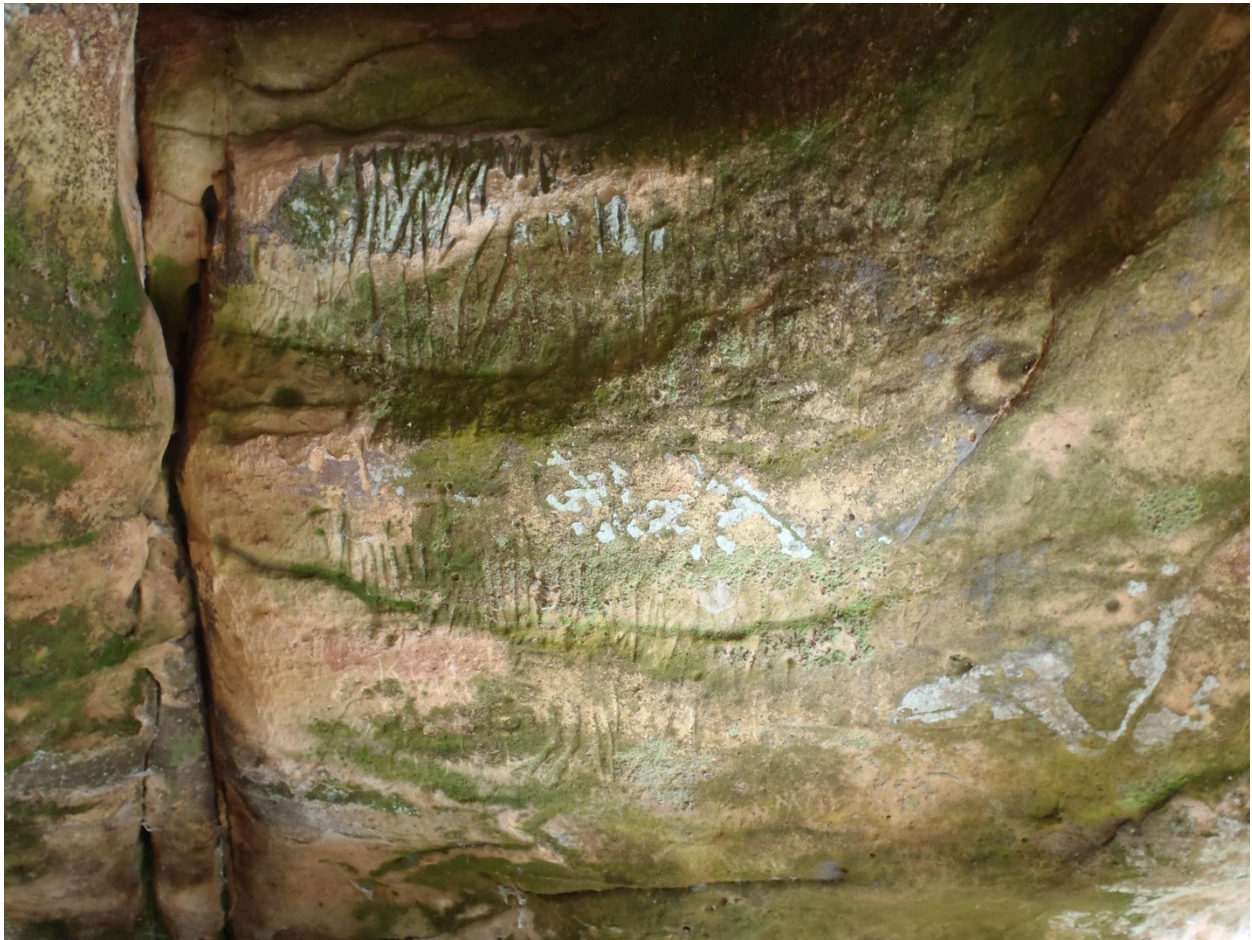
B.13 – Edgemont Panel 1, near the opening of the cave. While there were historic images of this panel as well, poor lighting and moss activity made collecting an accurate repeat prohibitively difficult. Photograph by author, 2014.

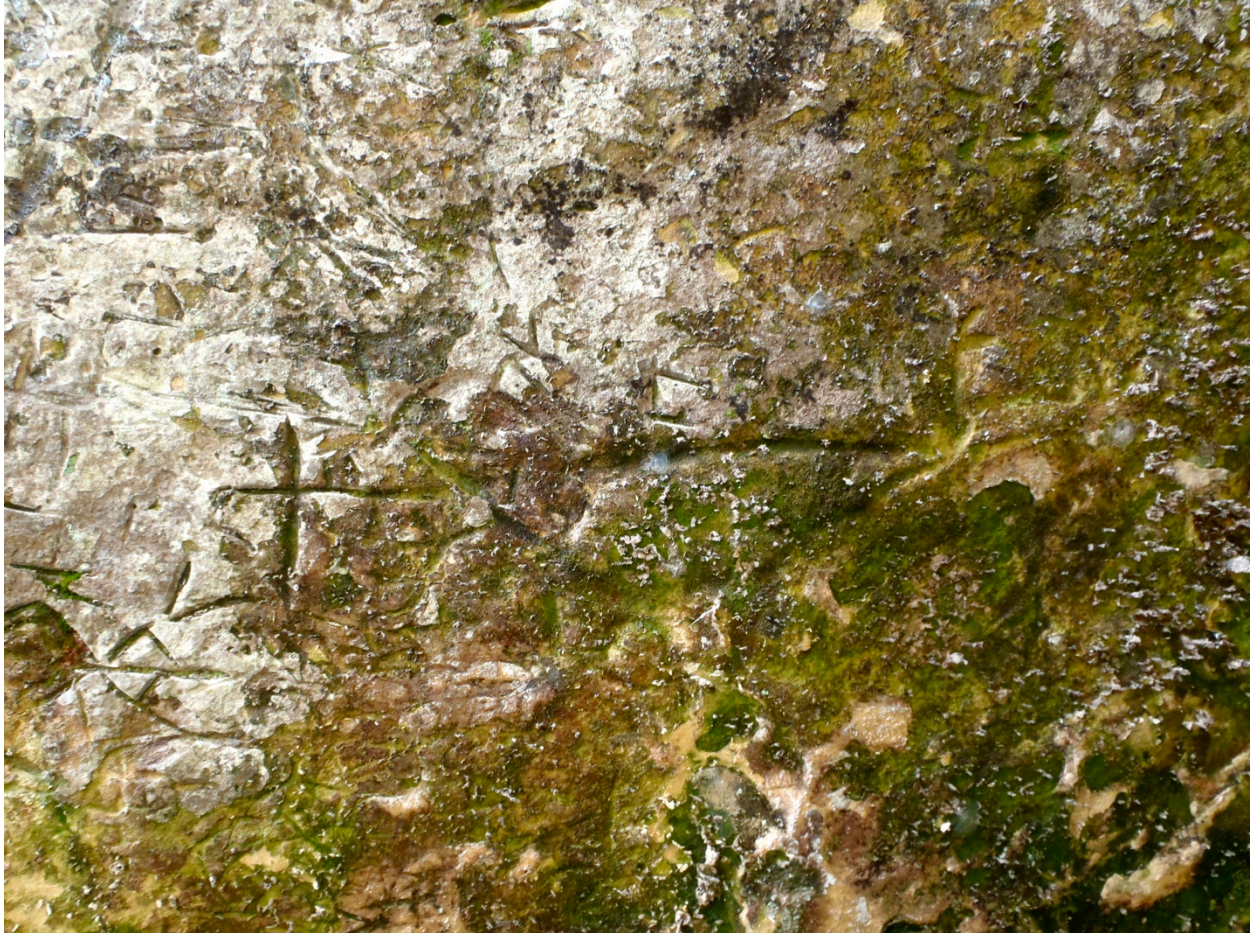
B.17 – Front and back of completed RASI score sheet for Edgemont Panel 6.

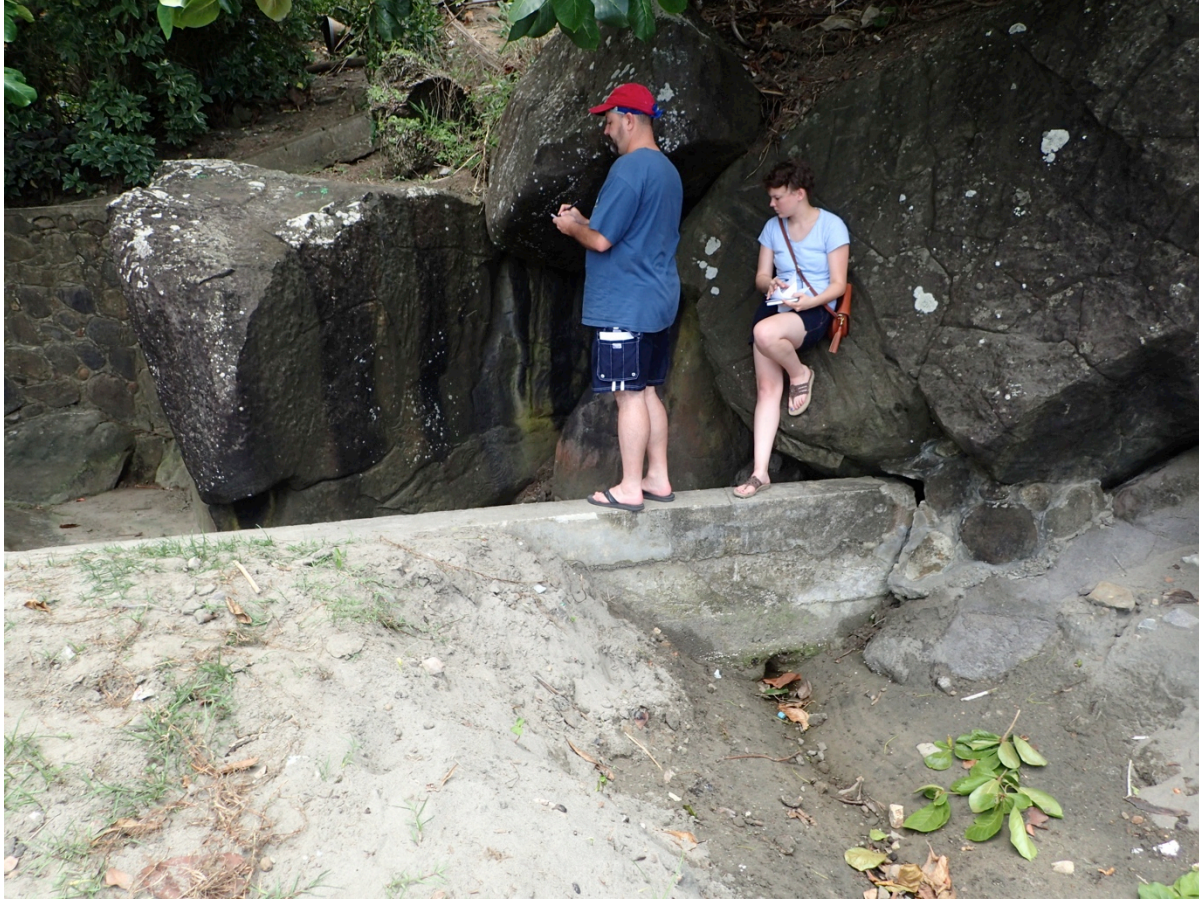
C.2 – The backside (panel 2) of the main boulder at Duquesne Bay with Dr. Casey Allen and Cayla Kennedy conducting RASI assessments (Permission acquired from both individuals). The new drain being beneath the retaining wall is visible in the lower right corner of the image. Photograph by author, 2016.

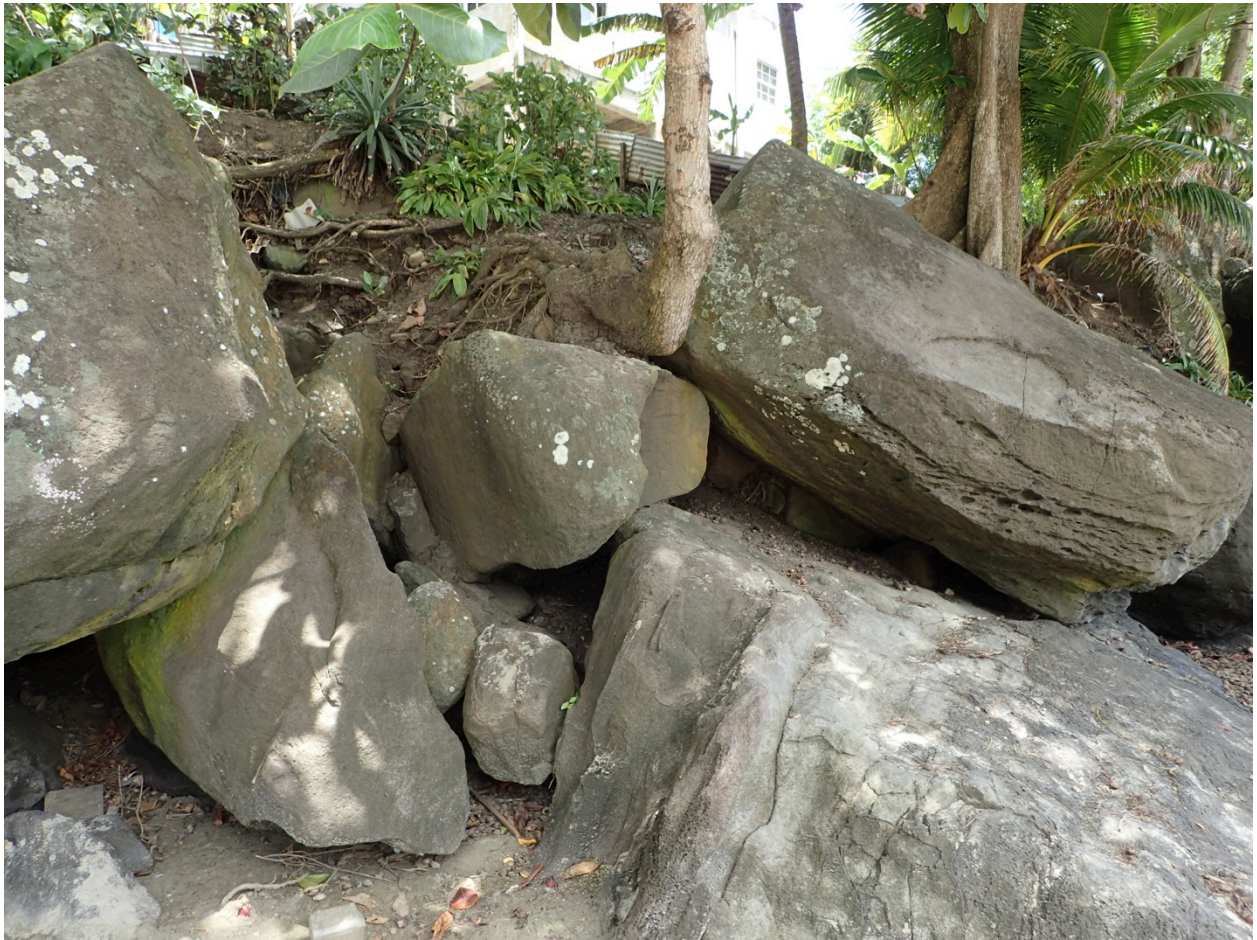
C.3 – Image of the small boulder (center beneath the tree) housing panel 3 at Duquesne Bay and surrounding boulders. Facing the ground, it is very likely this boulder was once upright and has since fallen, leaving the panel in a fairly precarious position. Photograph by author, 2016.

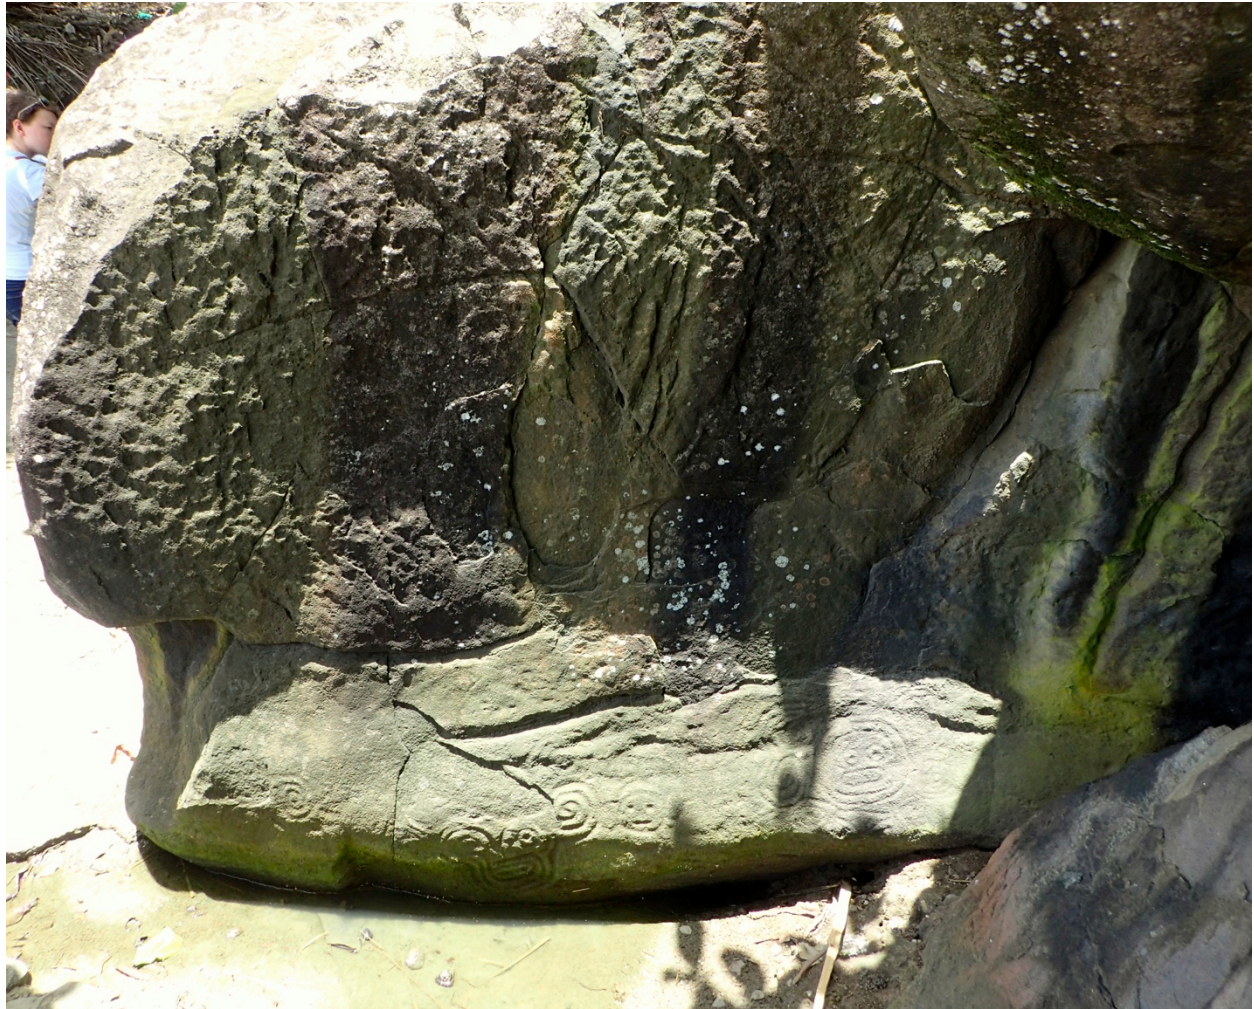
D.1 – Duquesne Bay Panel 2. Often inundated with run off and flooding, pools of standing water can be seen in the lower left corner. Numerous “bathtub rings” along the base and colored deposits running down the right side of the panel illustrate the significant impact water can have on rock art panels. Photograph taken by author, 2015.

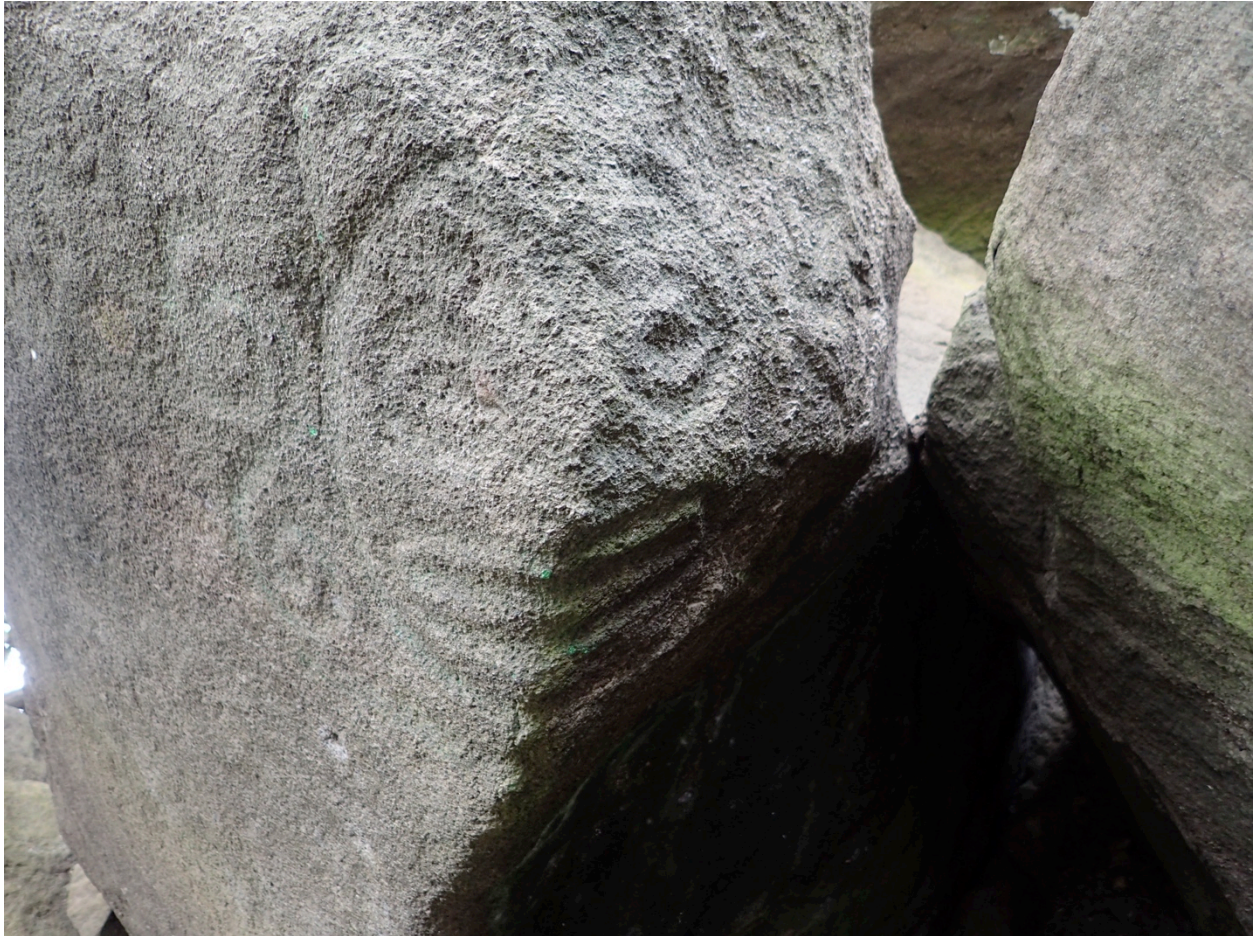
D.4 – Duquesne Bay Panel 3. Bridging two sides of its host boulder and facing the ground, this panel is unique among the Grenadian petroglyphs. Photograph taken by author, 2015.

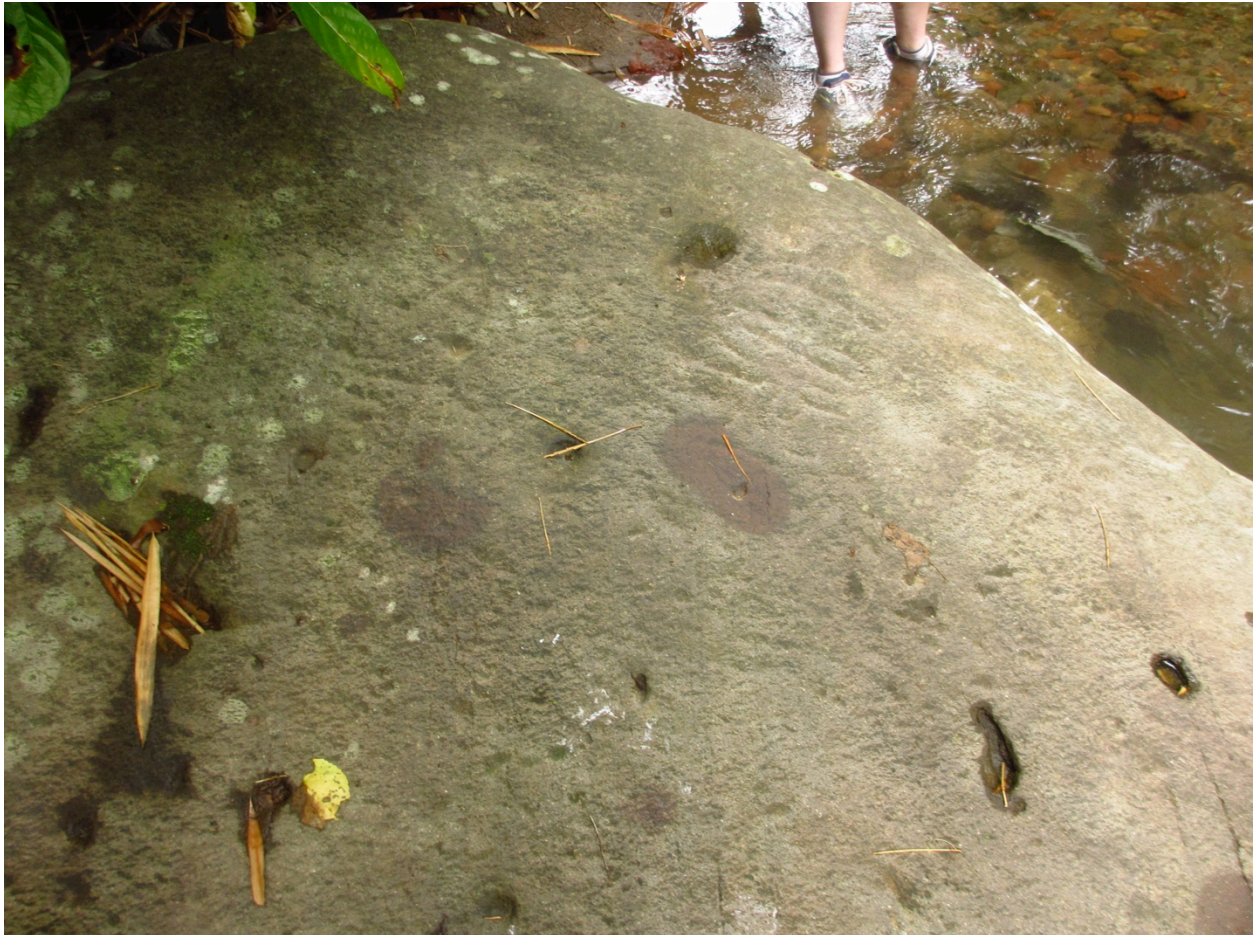
D.7 – Mt. Rich Panel 1. Very faint, the lone petroglyph on panel one (upper right) can only be seen in certain light, when wet, or when filled with fine debris, as seen here. Photograph provided by C.D. Allen, 2012. The photograph is older than the assessment year but this panel was fairly unaffected by the 2015 cleaning as it is the farthest from the primary boulder housing most of the site's petroglyphs.

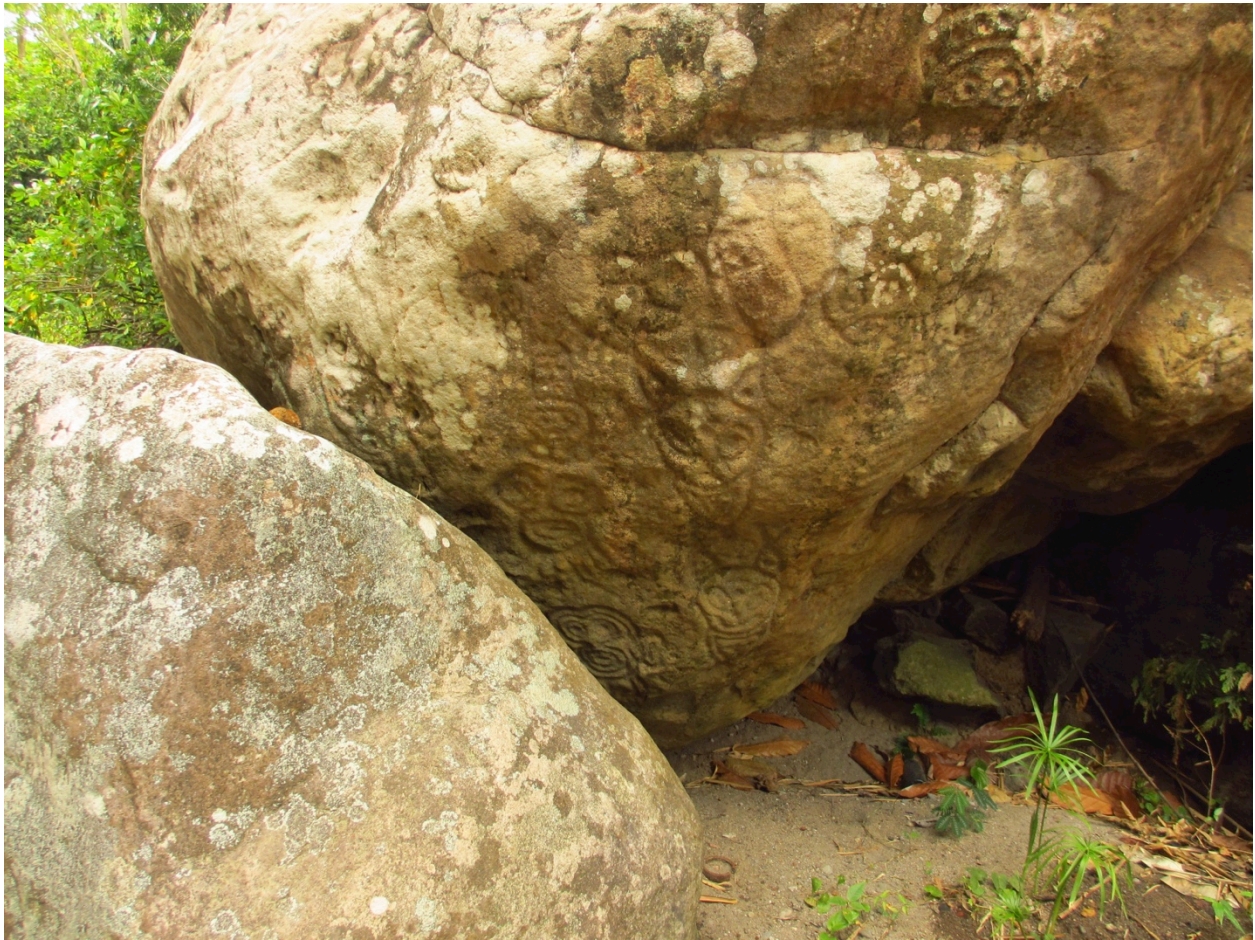
D.12 – Mt. Rich Panel 8 with the only known big cat motifs in the Lesser Antilles. Because the panel is located on the upstream side of the main boulder, little rock coating or lithobionts have grown on its surface. Photograph taken by author, 2015.
